GCOS TECHNICAL SUPPORT PROJECT PACIFIC

Tarawa, Kiribati, Station Number 91610 - Training in new Proton Hydrogen Plant

QUARTERLY REPORT

APRIL - JUNE 2005

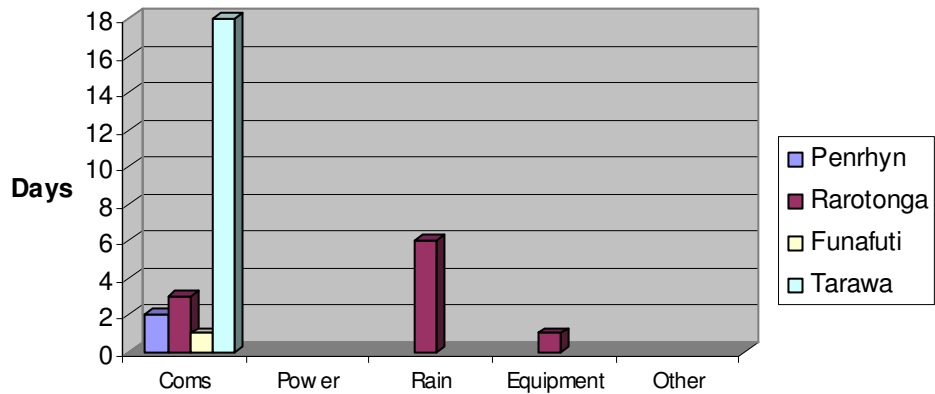
Upper Air Stats - April 2005 Problems

The “Problems” chart provides a breakdown of areas in which problems occurred at the stations. The "Other" category encompasses occasions when no information has been provided from the station and we have been unsuccessful in discovering the reason. It is also used for depleted stores. The “Rain” category applies to radar wind finding and signal loss due to strong rain echoes.

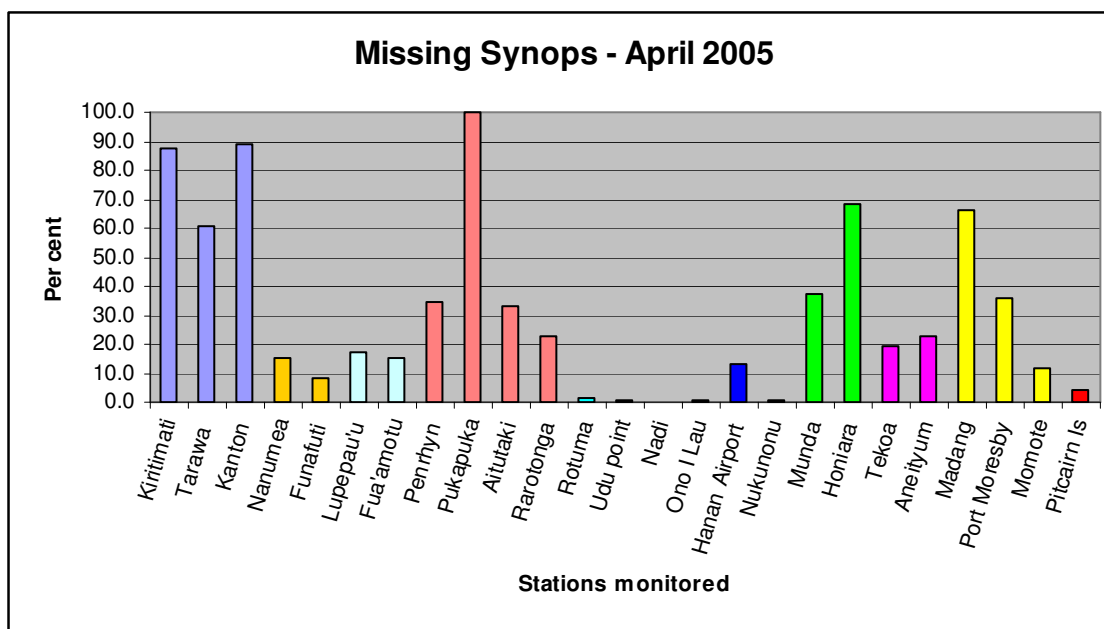
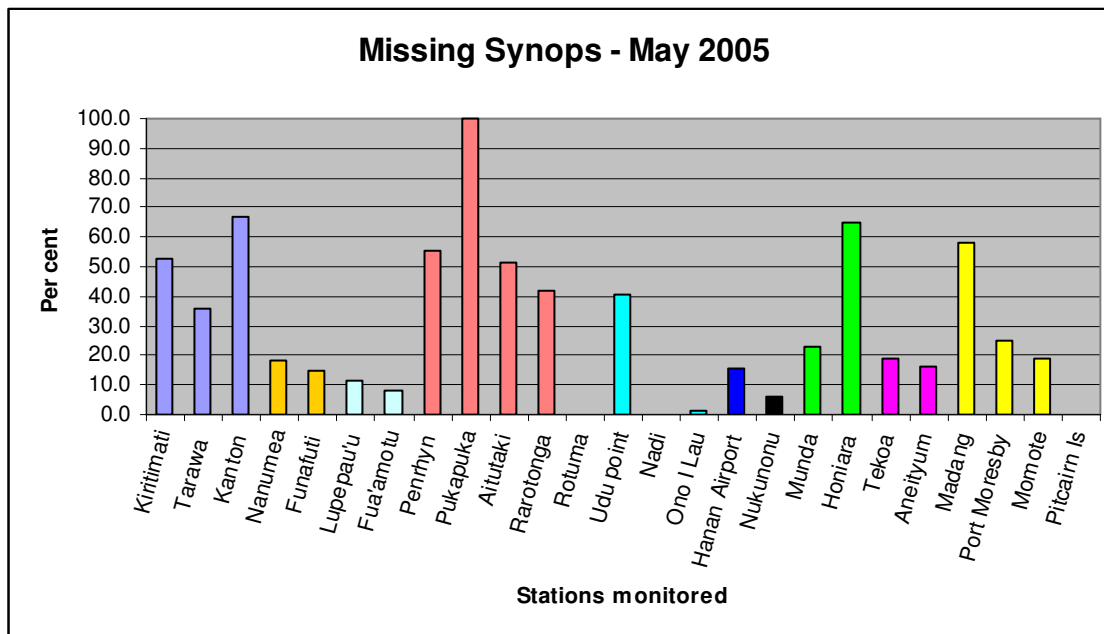
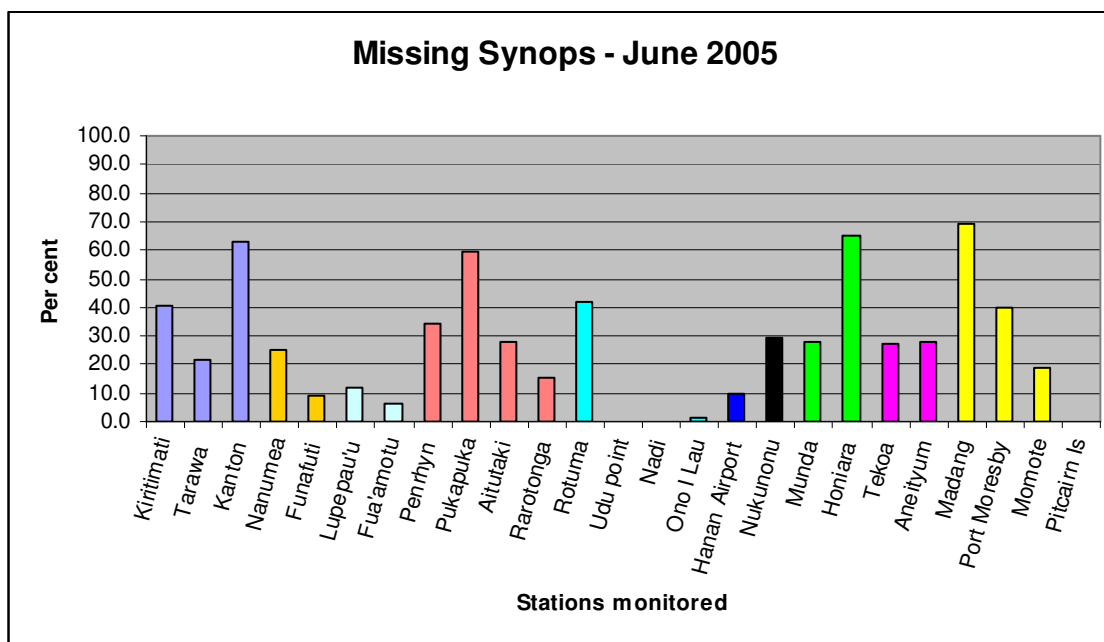
4.2 GSN Station – Missing Synoptic Reports

The chart shows the number of missing synoptic reports from the region's GSN stations that are passed through MetService's gateway or currently monitored by MetService.

The total number of synoptic reports possible is determined from WMO Tables showing each stations reporting program. Where it seems that the advised reporting program is not up to date, as far as practicable, we will adjust total number of synoptic reports used in the calculation.

Stations are "colour coded" according to country.
